Hydrocarbon Fuel/Combustion- Chamber-Liner Materials Compatibility

Contract NAS 3-25070
Interim Final Report
NASA CR-185203
April 1990

Report No. KBQ-FR-1
NASA CR-185203

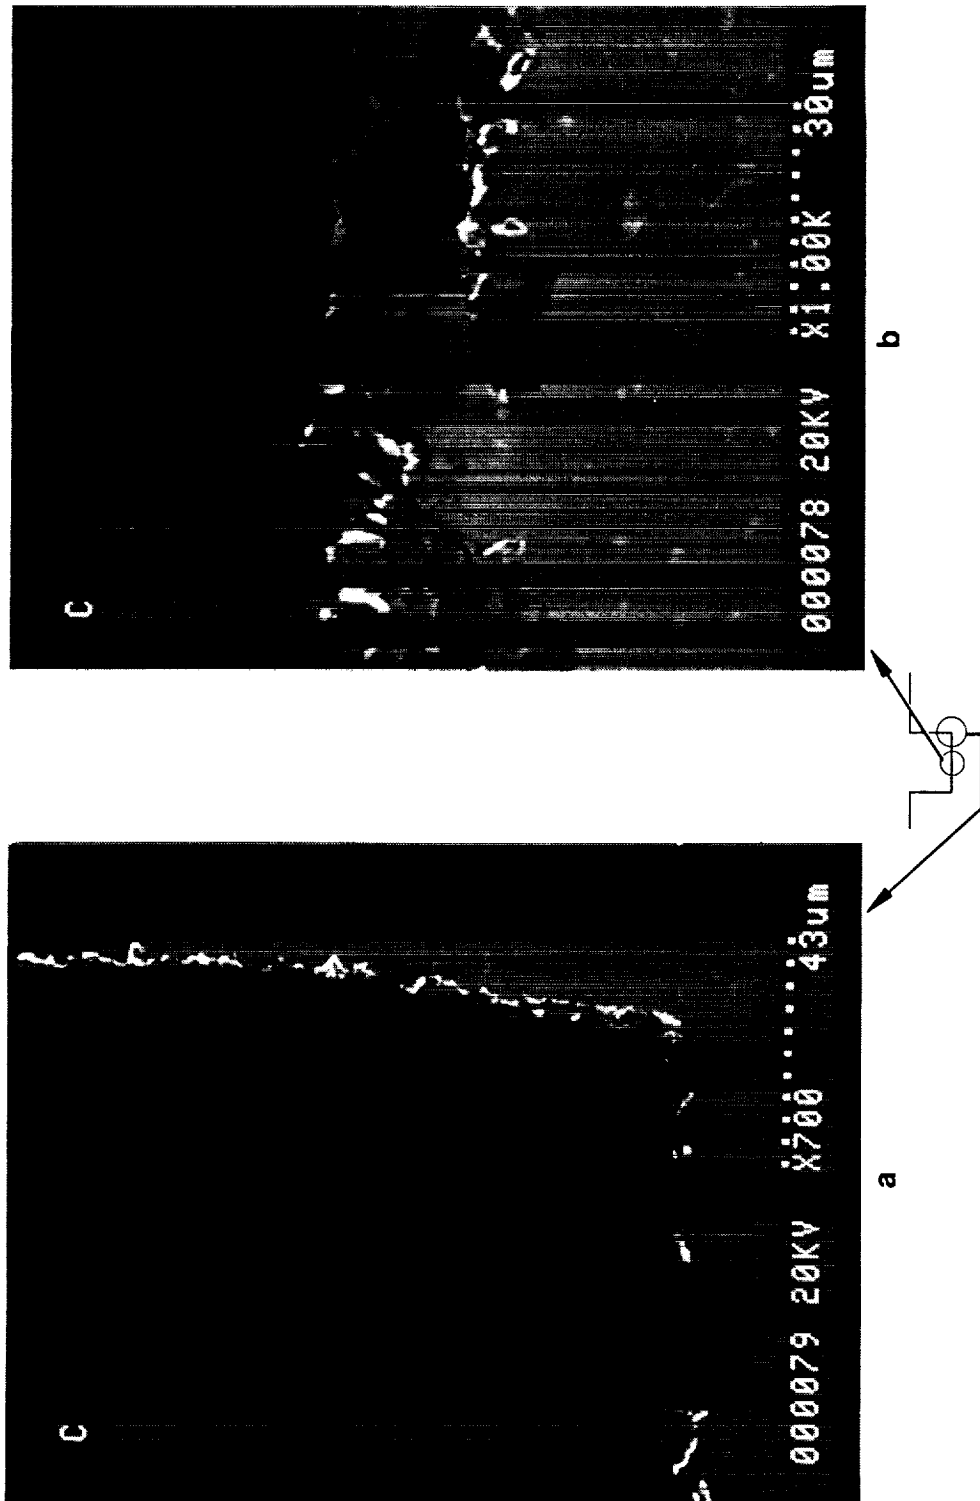
Figure 86. Sample C, Acid Nickel Followed By Alkaline Nickel and Gold. (a) Cross Section of Bottom Corner of Channel. (b) Channel Bottom Note: Bright Spots are the Gold Covered Regions

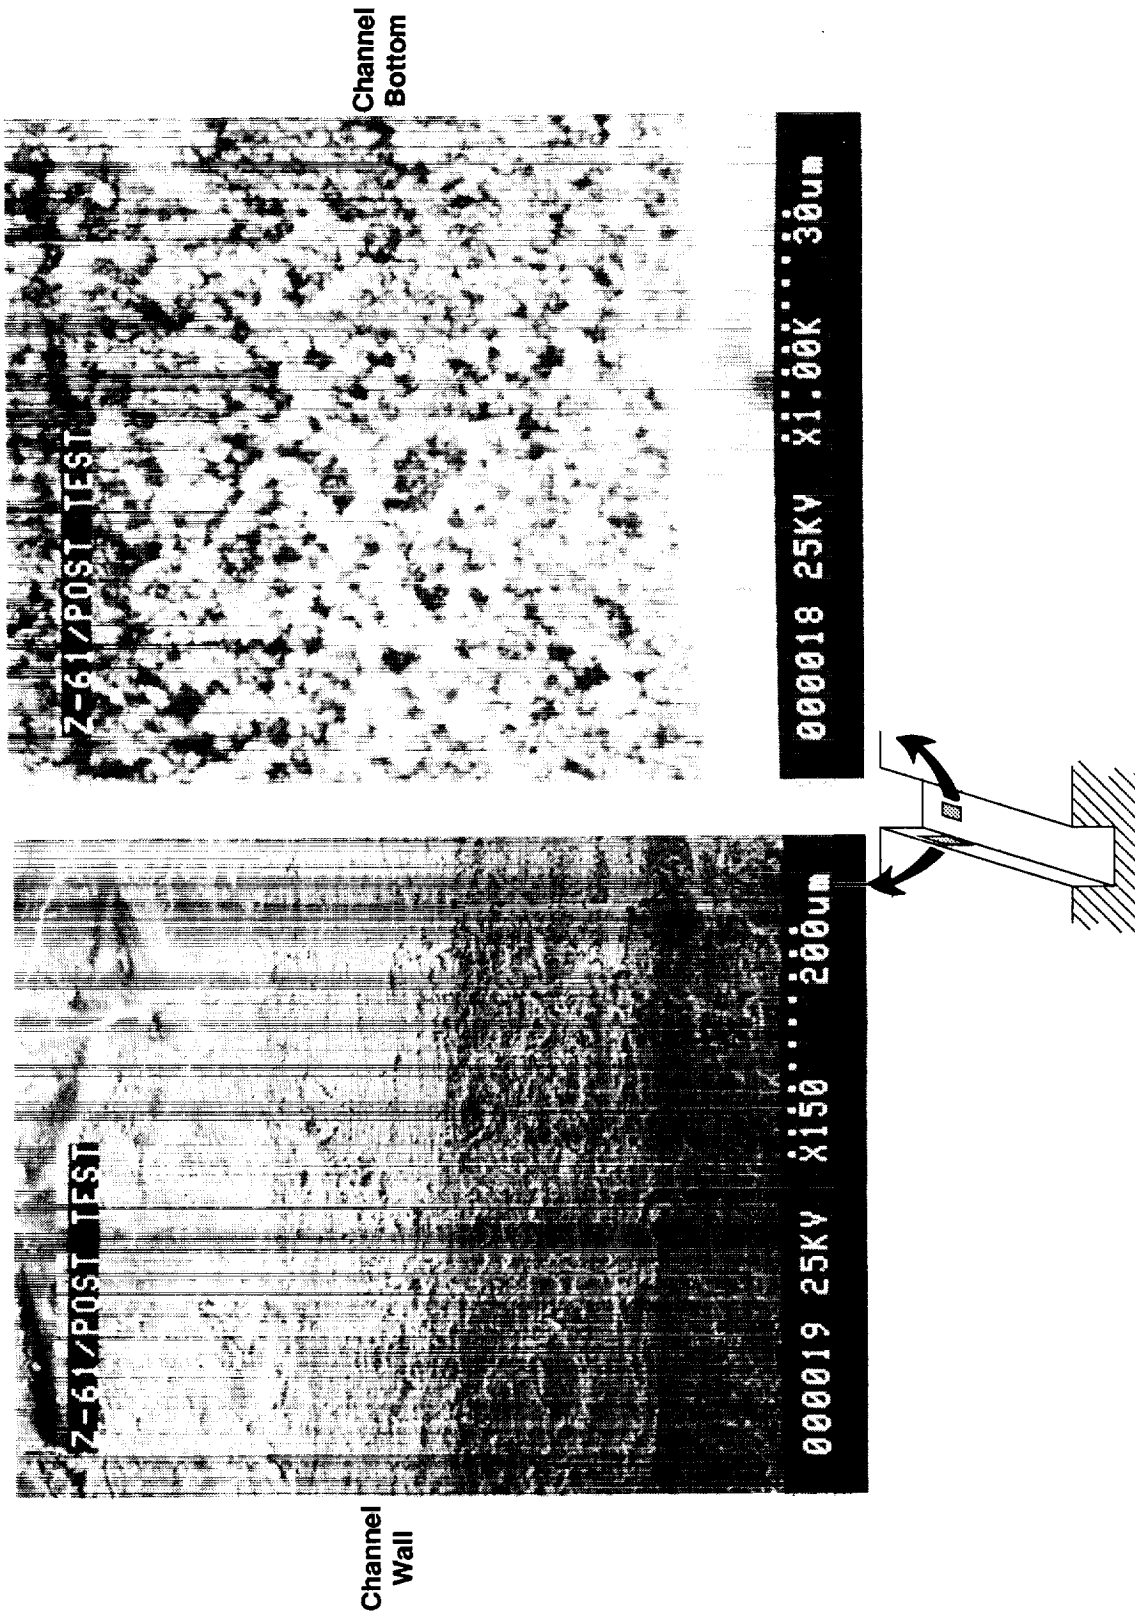
Figure 88. Post Test Examination Shows Wall Toughening and Scale Formation After 1169 sec of Operation with Tech Grade Methane in Test M201

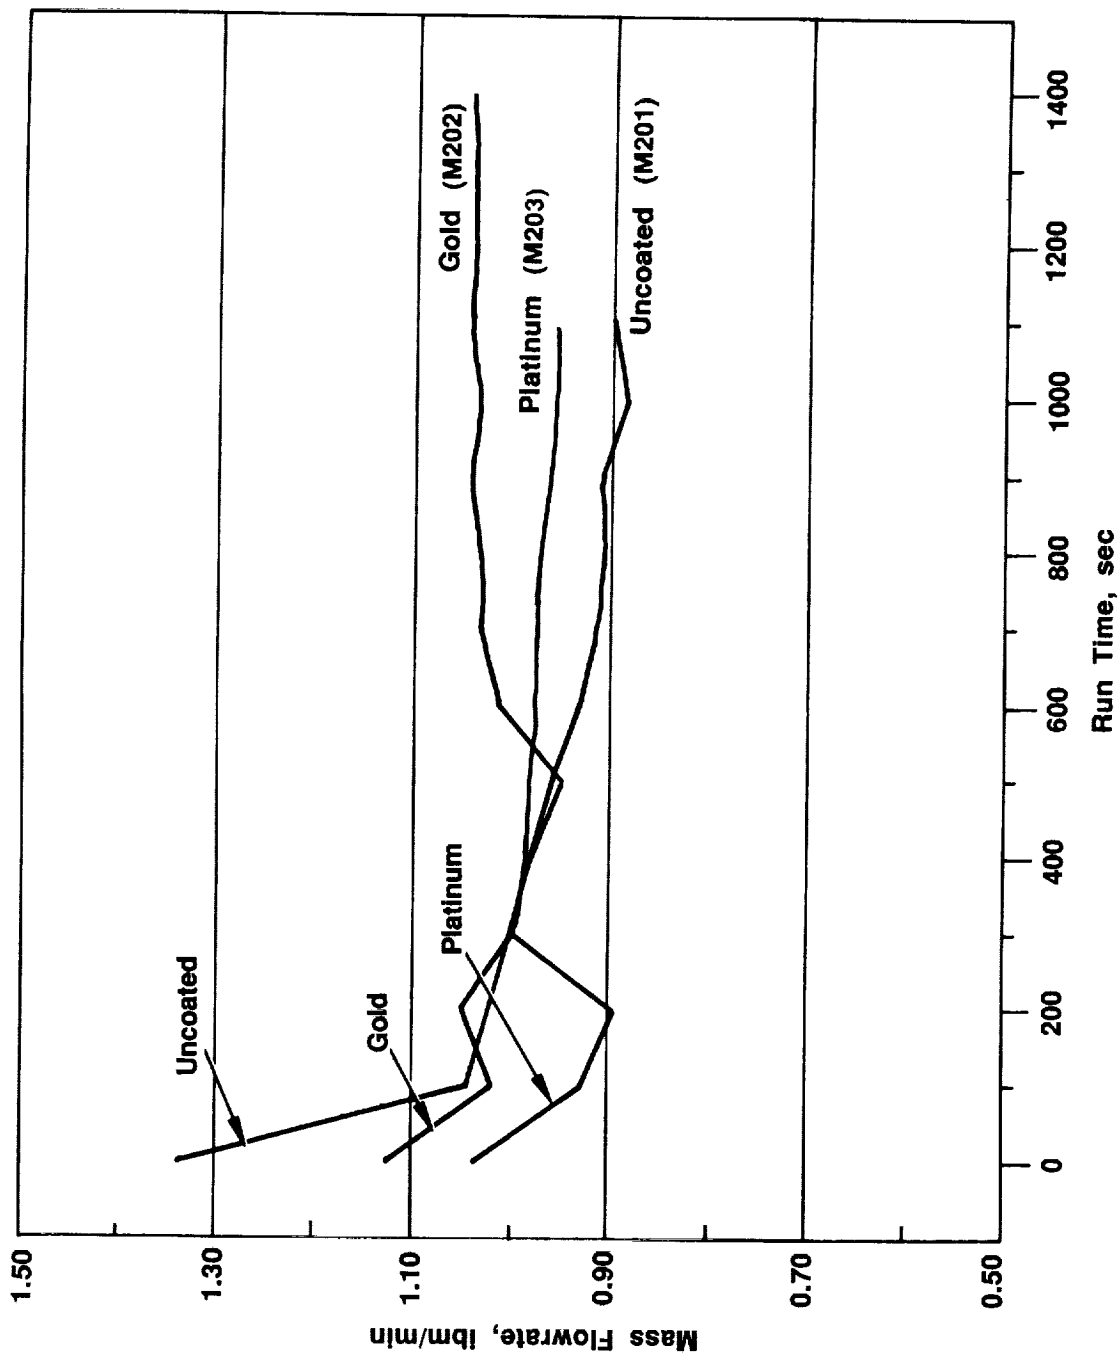
Figure 90. Flowrate Through Channel – Tests M201-M203 (Coatings Helped to Steady the Flowrate Through Channel.)

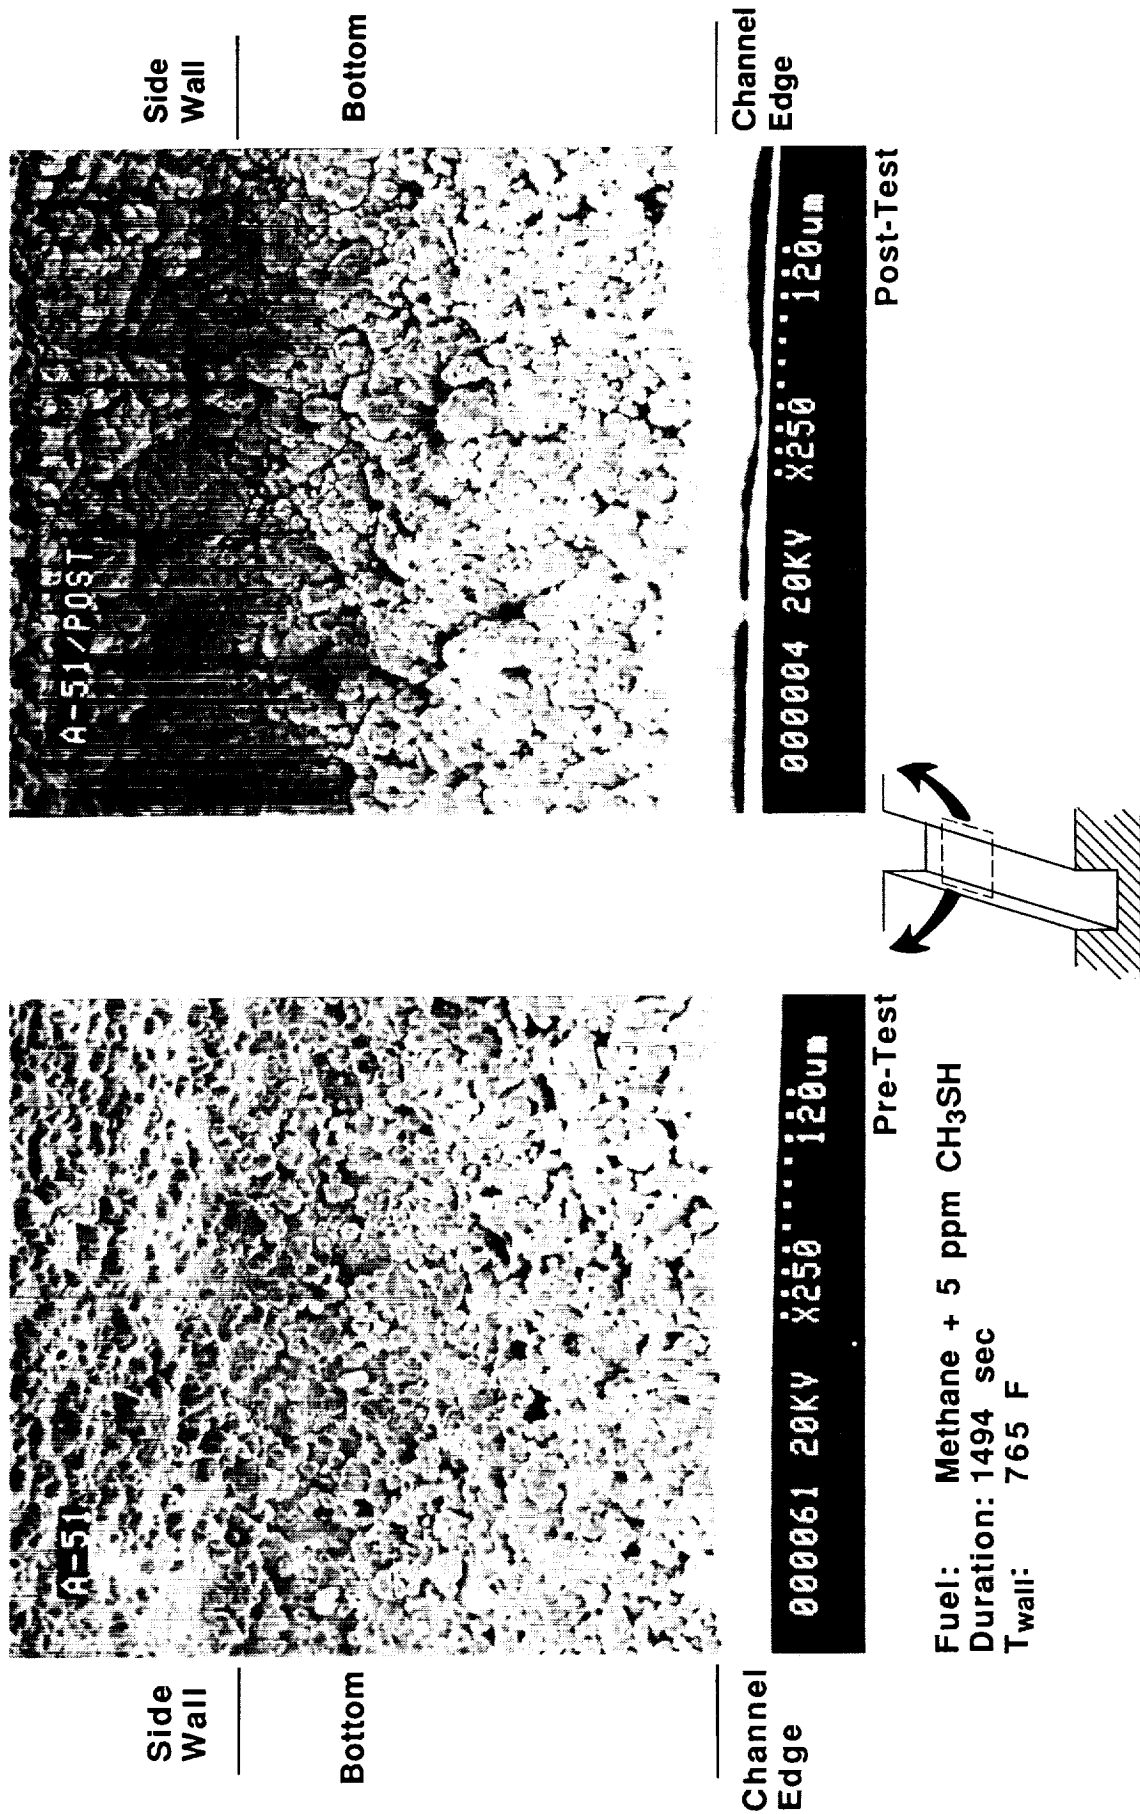
Figure 92. Gold Coating in Channel Provides Protection From Corrosion

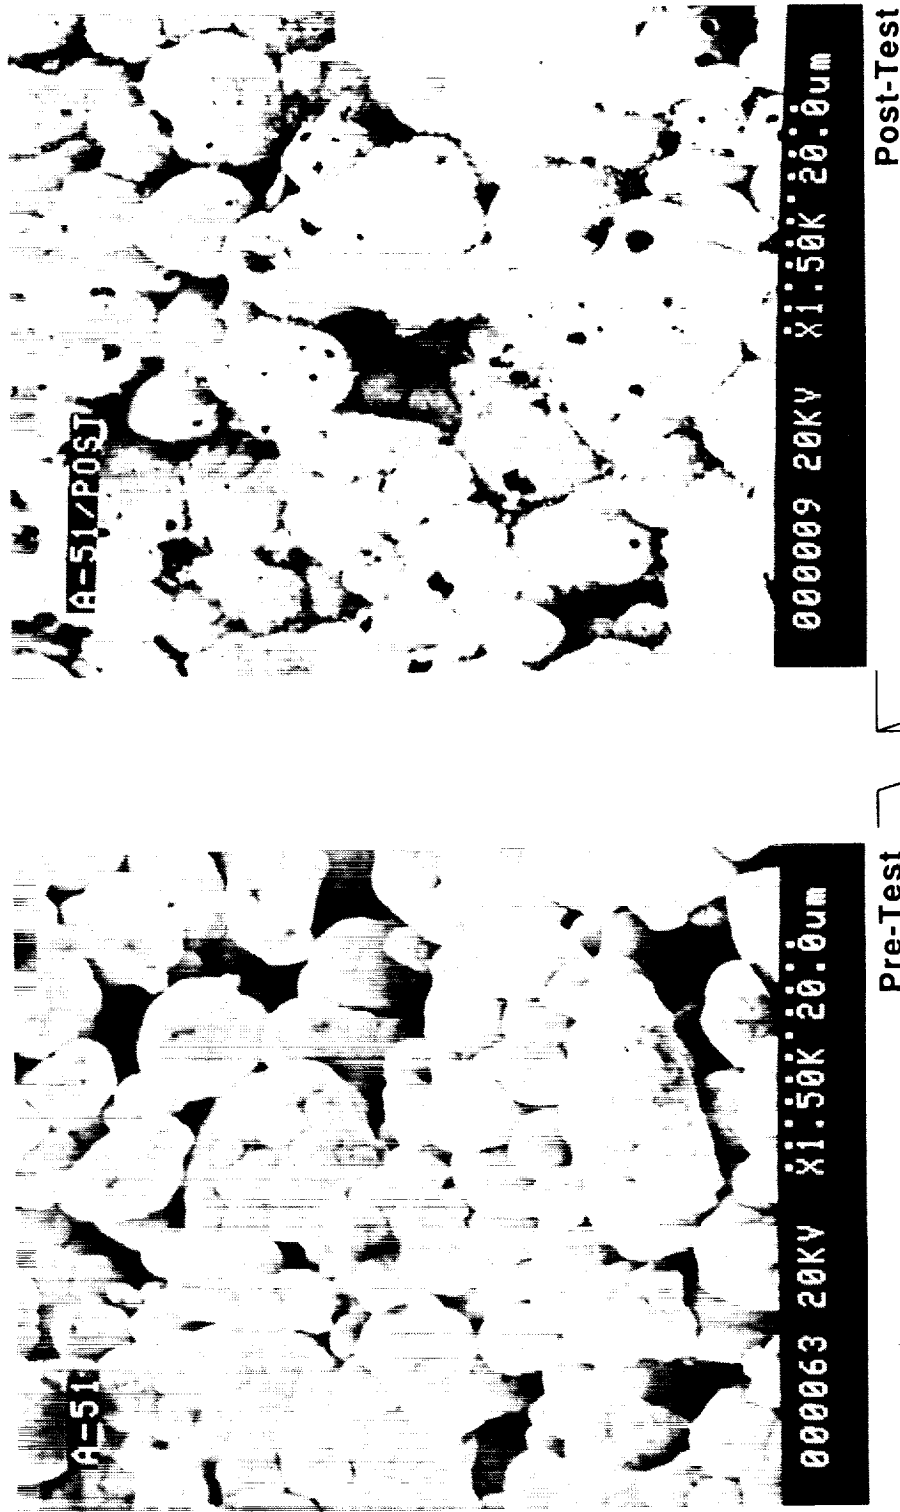
Figure 93. Enlargement of Gold Coating Shows Some Degradation Occurred During Test M202
(Note Fumaroles)

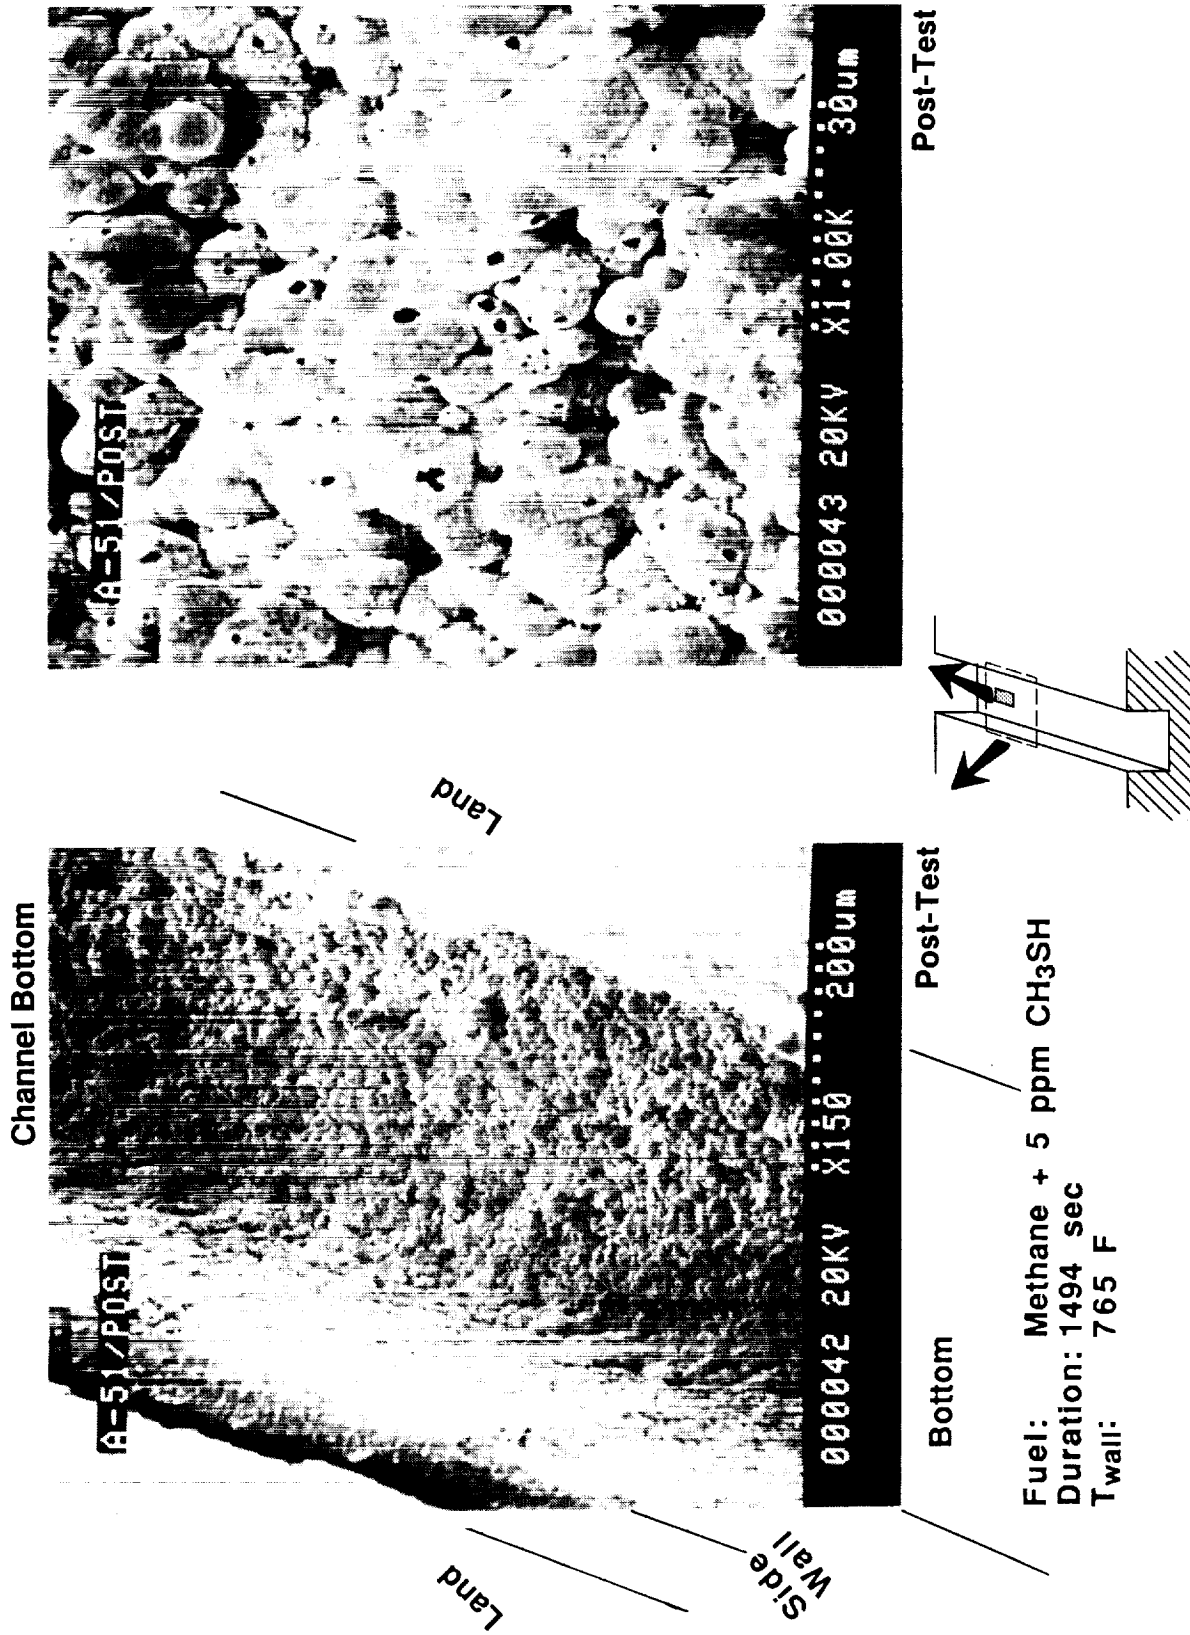
Figure 94. Gold Coating Disbonded At Sidewall and Small Fumaroles Developed During Test M202.

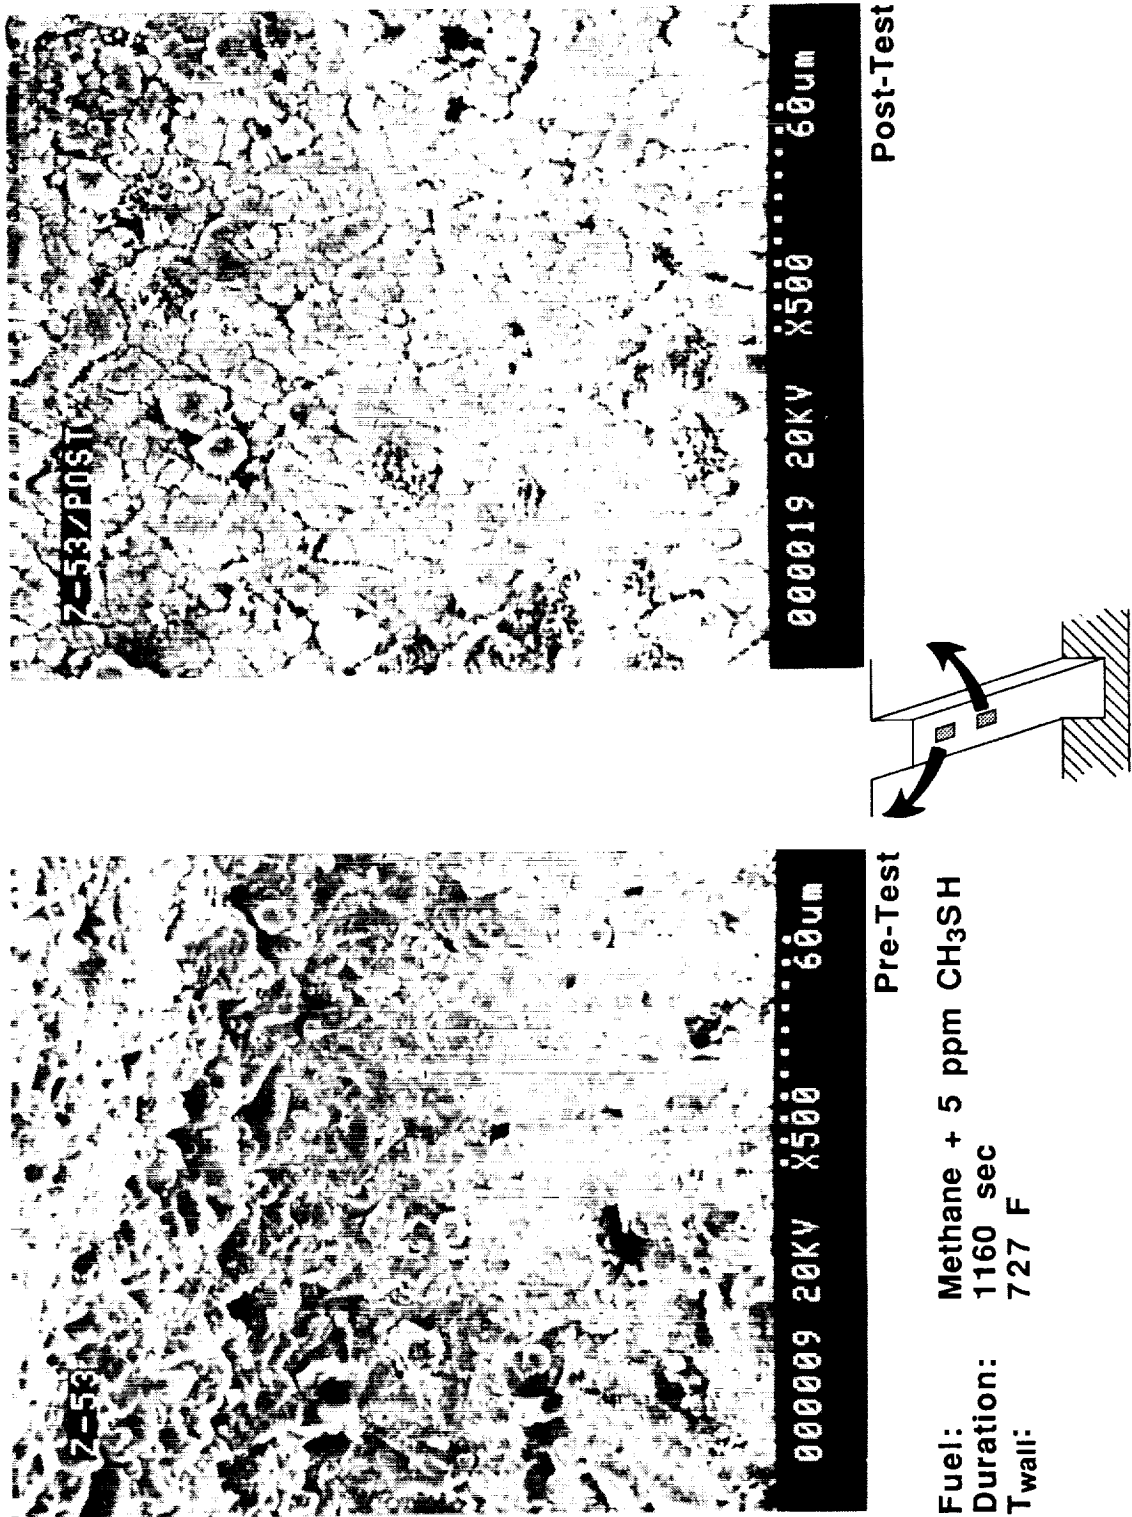
Figure 96. Minor Deposits On Platinum Surface Results In a Fuzzy Appearance With Random Lichen-Like Areas (Test M203)

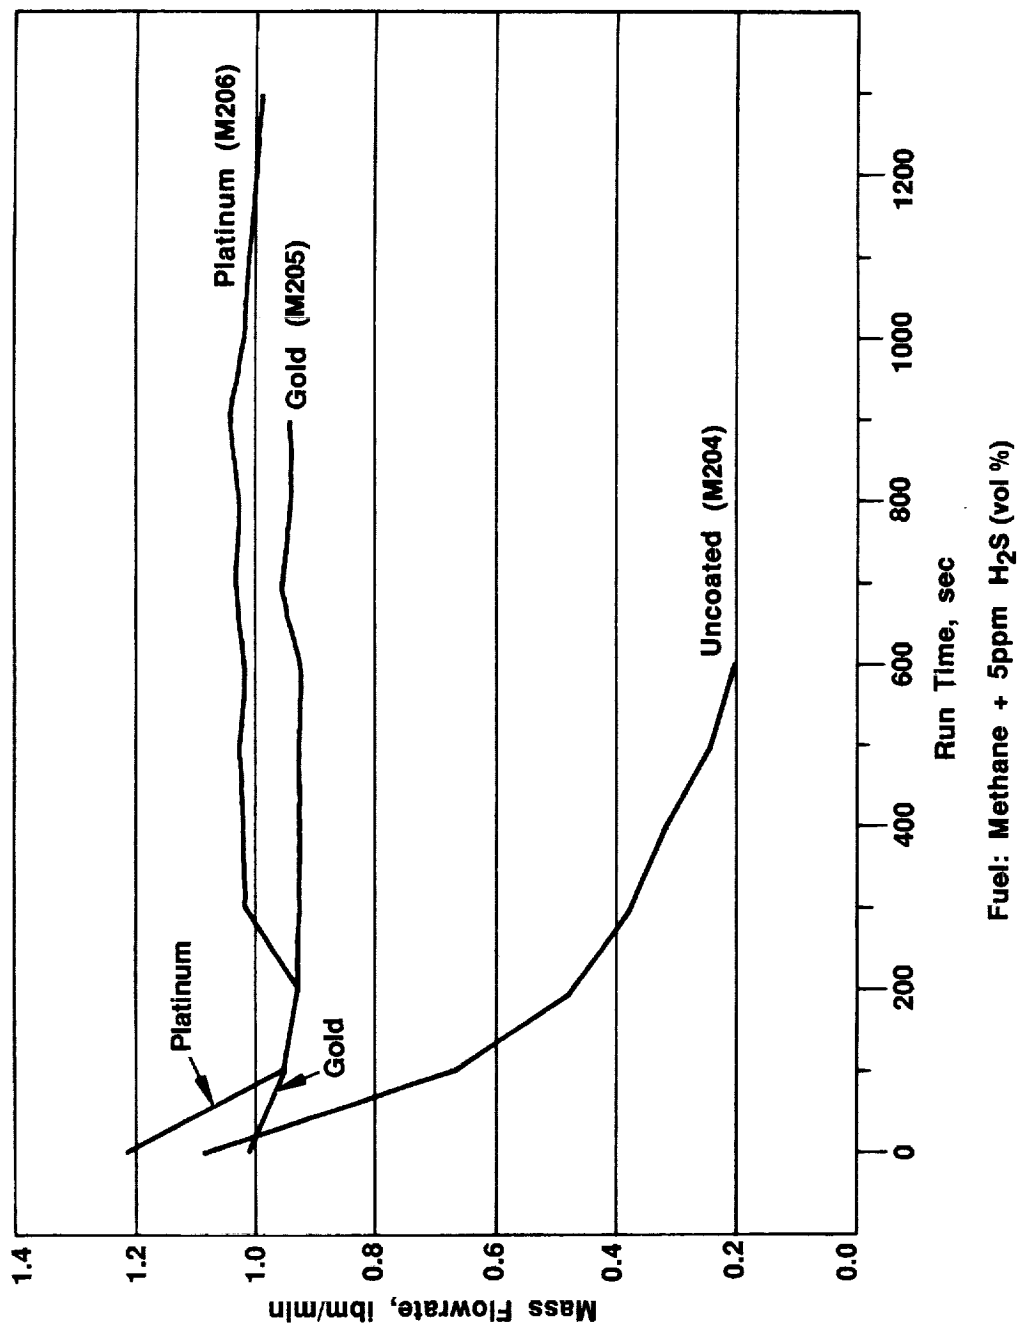
Figure 97. Flowrate Through Channel – Tests M204-M206 (Gold and Platinum Coatings Prevented Degradation of Methane Flow.)

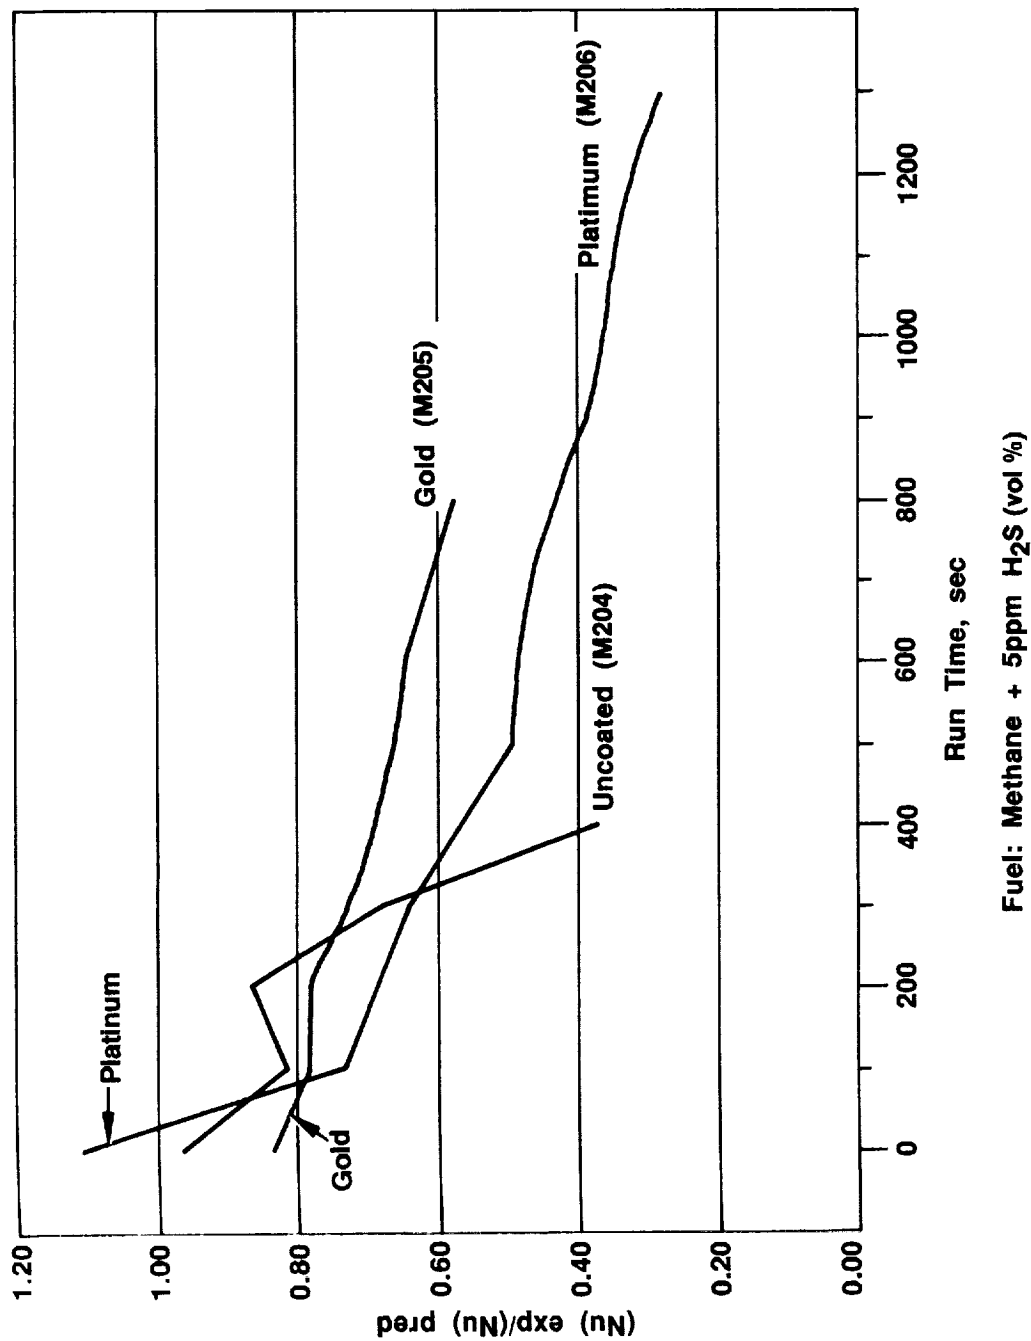
Figure 98. Heat Transfer Performance – Tests M204-M206 (Preliminary Data Indicate Gold and Platinum Coatings Do Not Prevent Decreases in Heat Transfer Performance.)

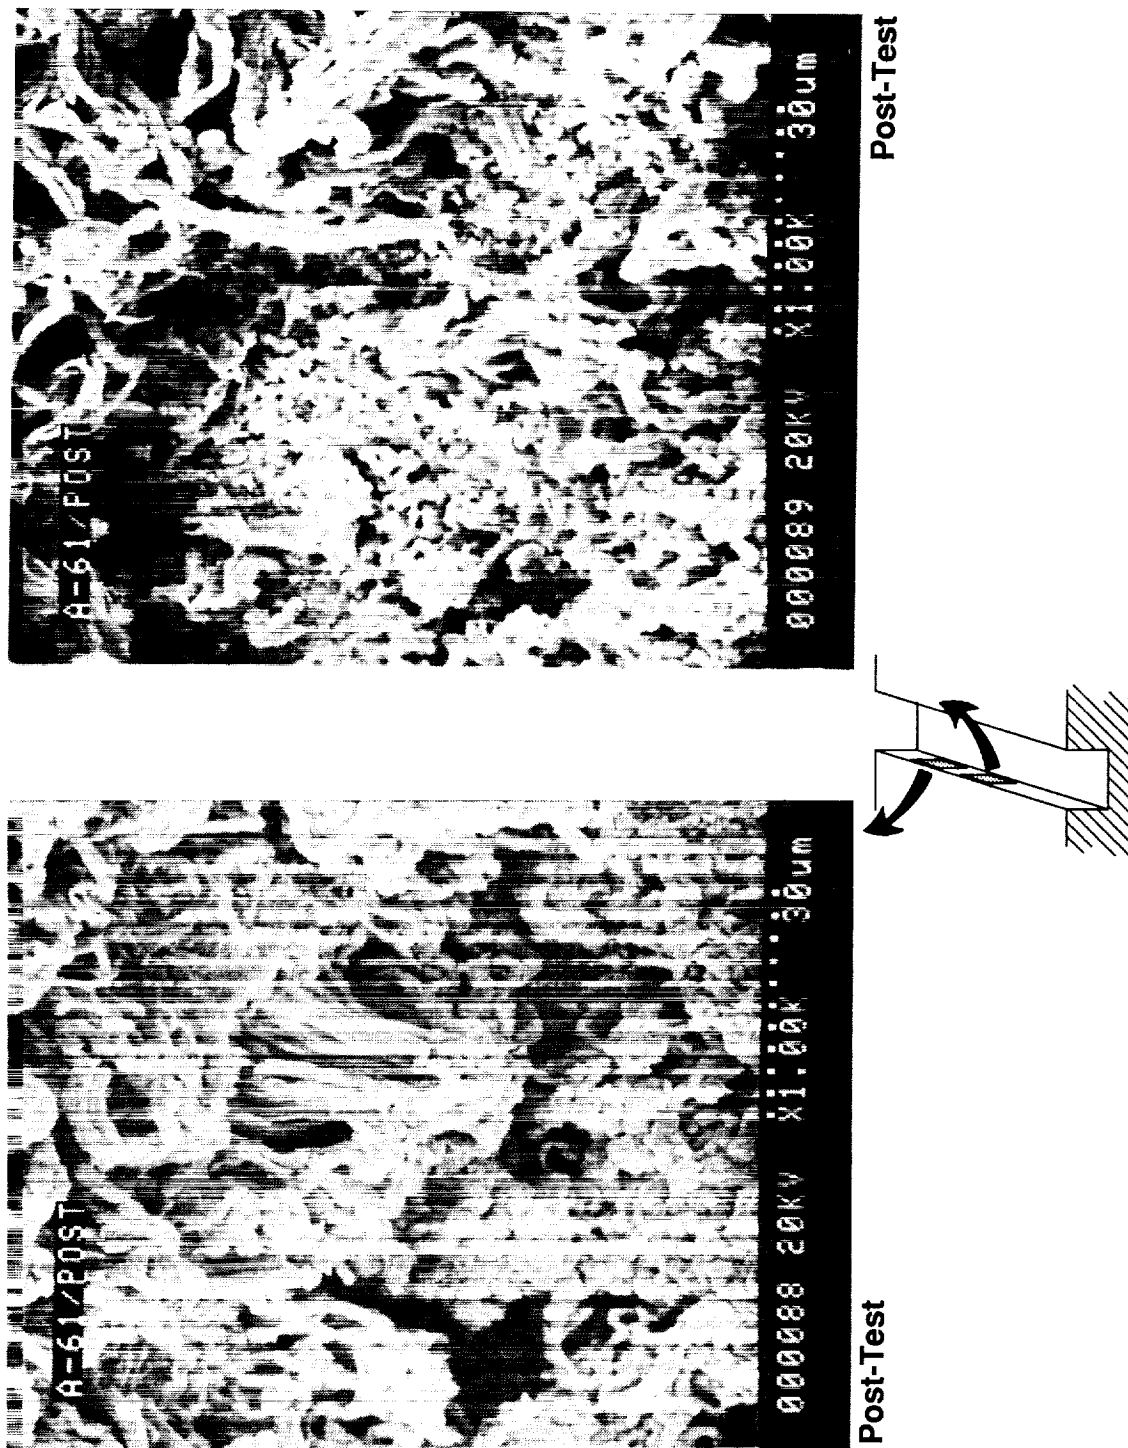
Figure 99. SEM of Uncoated Specimen - Post-Test M205 (Unprotected Amzirc Surface After Operation With Methane + 5 ppm (by vol.) H₂S. Growths Are Copper Sulfide.)

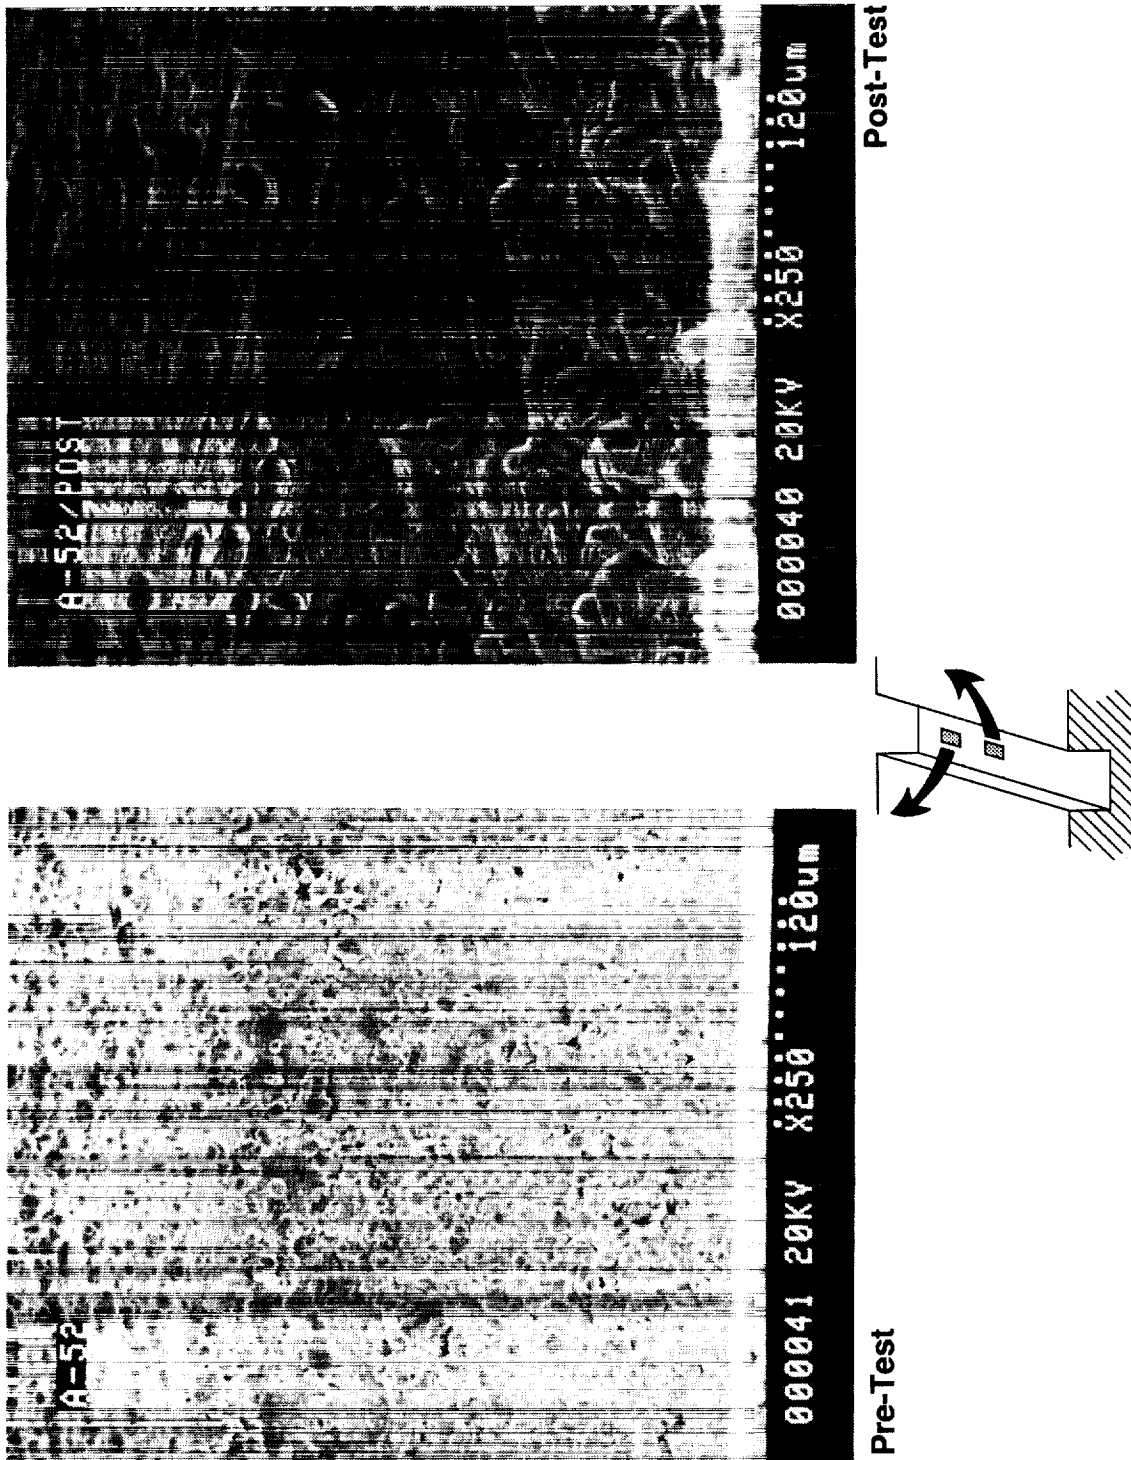
Figure 100. Pre- and Post-Test SEM of Gold Coating Used in Test With Methane + 5 ppm (by vol.) H_2S (Test M205). Post-Test Surface Has Even Coating of Copper Sulfide.

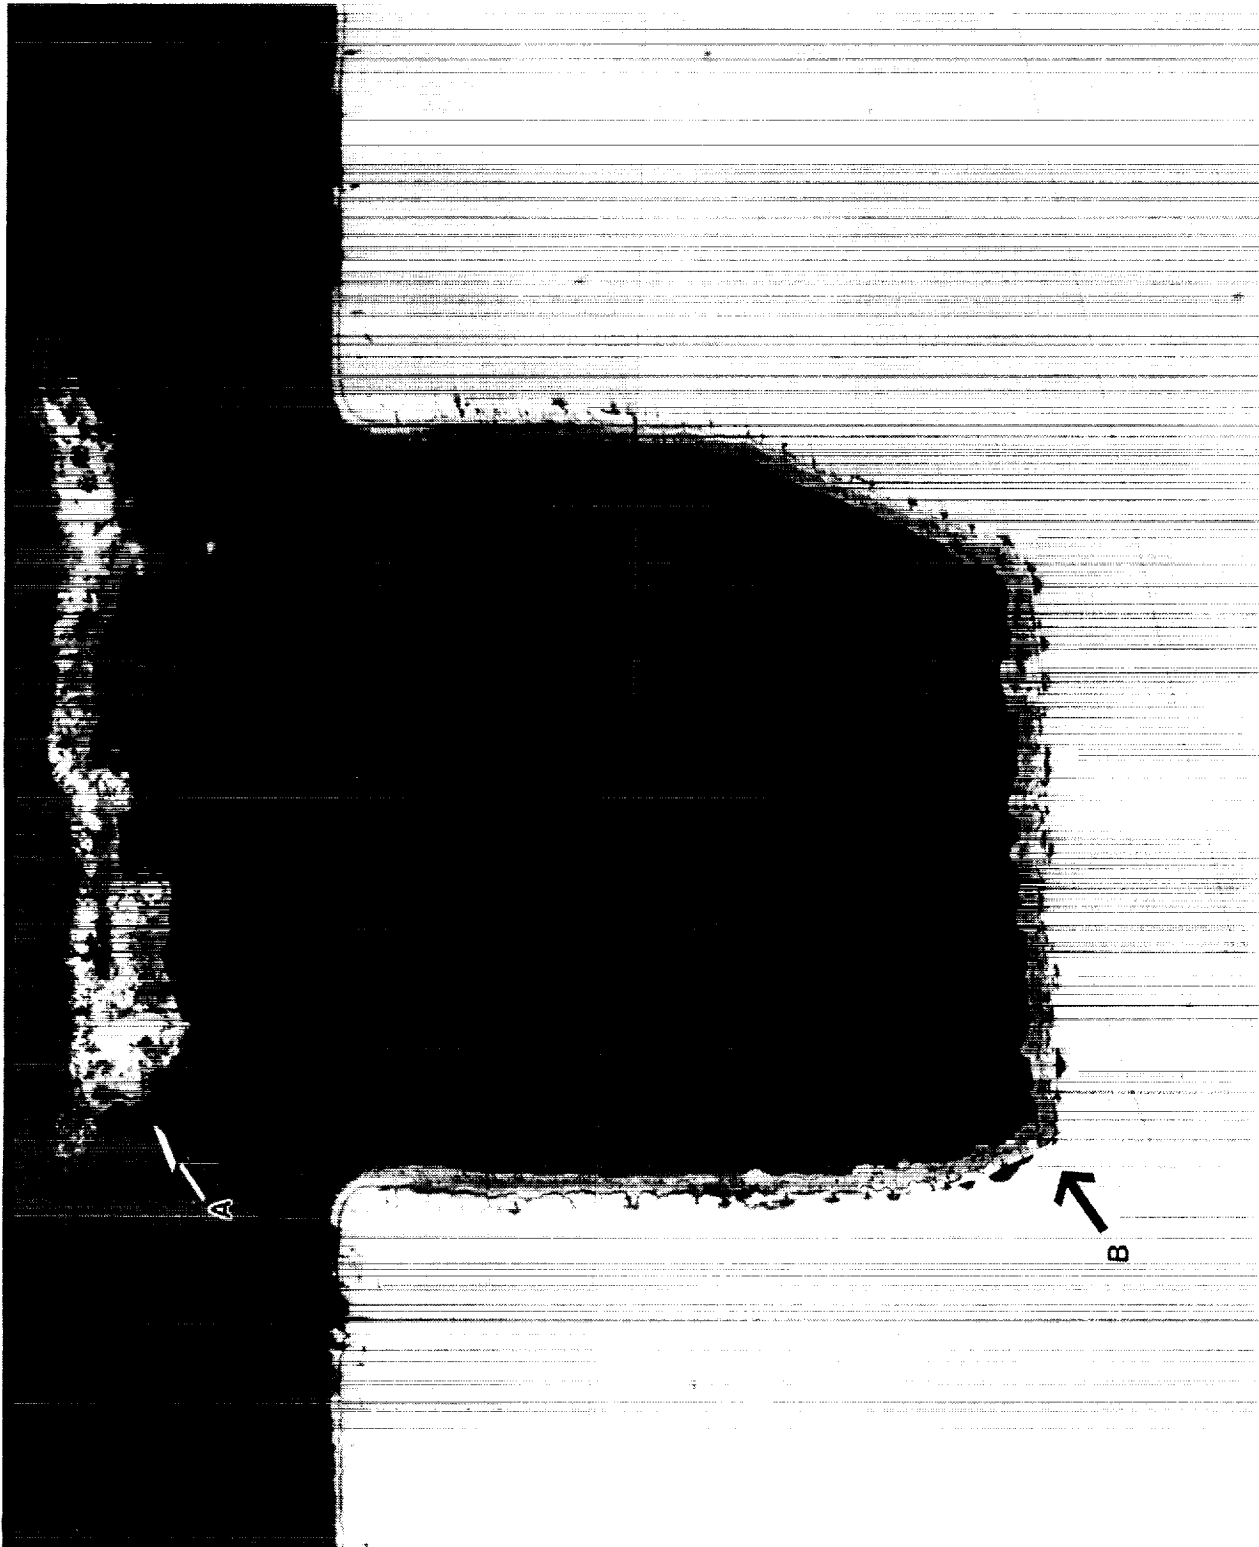
Figure 101. Cross Section of Specimen A52 After Test With 5 ppm H₂S (Test M205).
Note Thick, Even Distribution of Cuprous Sulfide

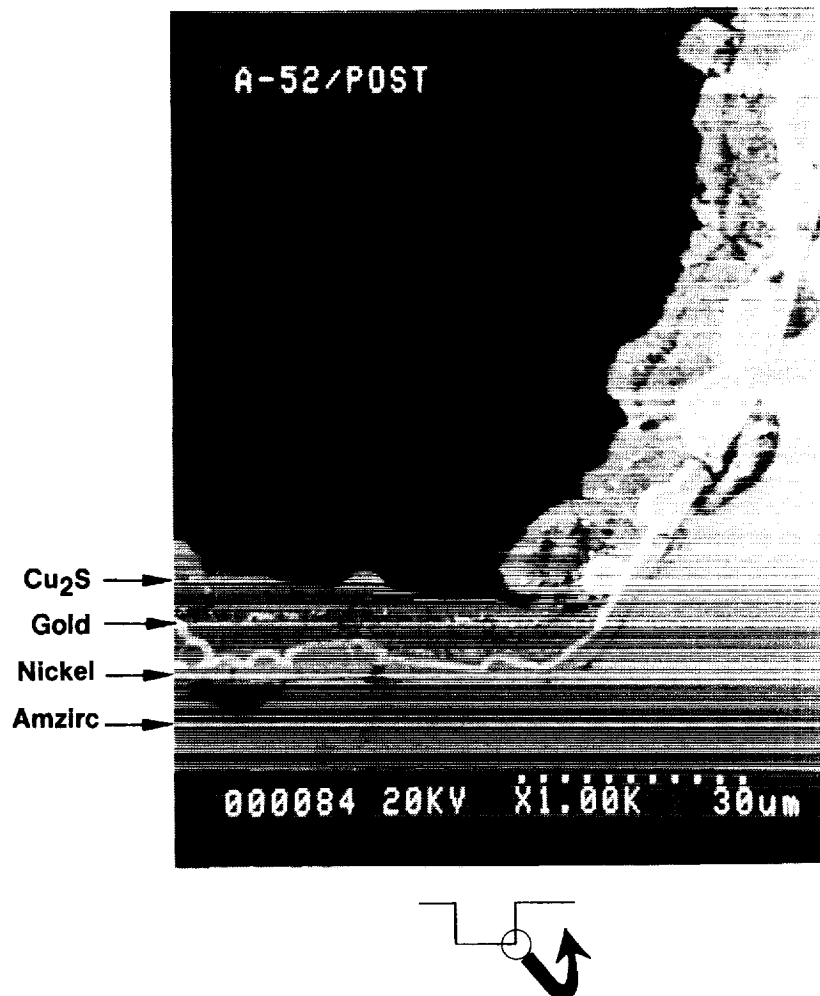
Figure 103. Cross-Section of Channel Corner After Test With 5 ppm H₂S (Test M205).
Note Massive Cu₂S Layer Over the Bright Gold Coating

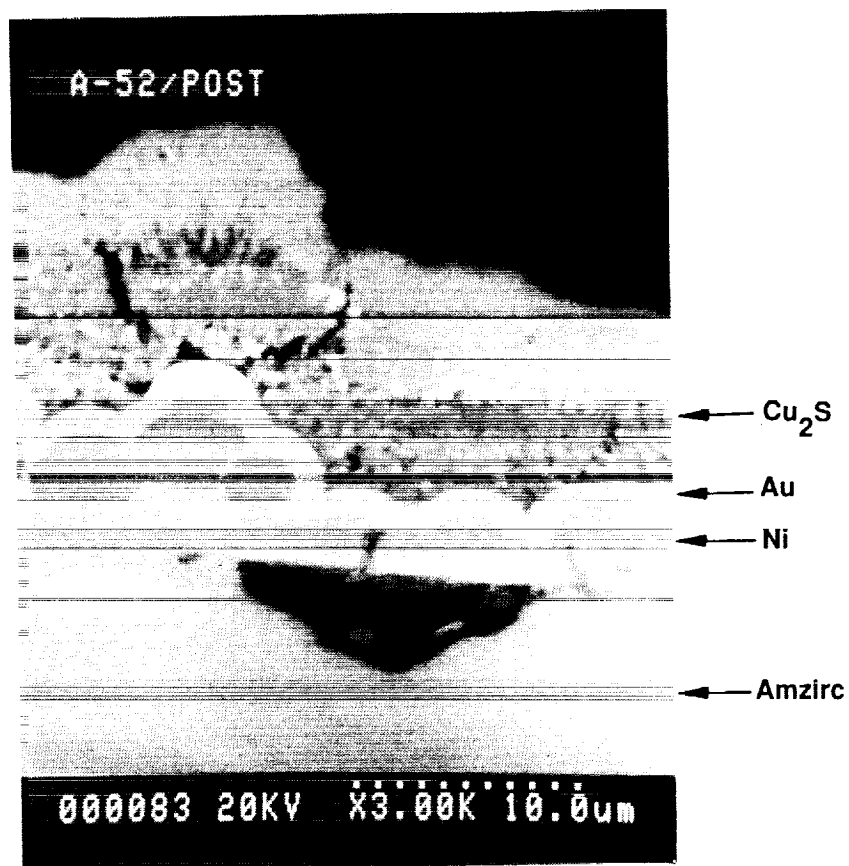
Figure 104. Closeup of Coating Crack and void Created in Substrate, Post Test With 5 ppm H_2S (Test M205).
